Drive & Coupling Solutions

MagnaDrive Fellside CHP, Sellafield, Cumbria.

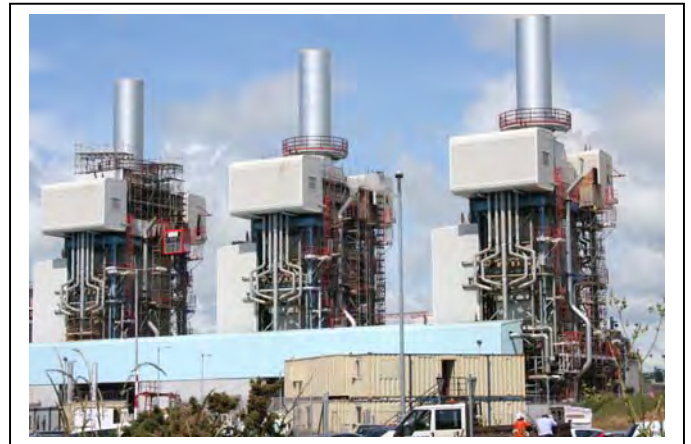
Two identical pumps were causing major maintenance problems due mainly to fixed pipe work arrangements. Pressurized water rising from ambient to 350C is pumped around a ring main system. This rise in temperature of around 330C caused the pump body and pipe work to grow and move significantly.

The main result of this excessive movement was manifested in disc coupling degradation. Stainless steel disc pack of the metal membrane type used in this spacer coupling application could not accommodate within their design the large transient misalignments created.

A solutions was put forward to replace the troublesome disc couplings with a Magnetic drive coupling that employs rare earth neodymium boron iron magnets in proximity to pure copper to generate an eddy current field strong enough to link these 350kW motor to their respective pump via a 6mm air gap.

The installation of 2 MagnaDrive FGC couplings to these pumps totally removed vibrations, restoring moments and all forces that had previously lead to the frequent coupling failure. In addition pump downtime through reduced bearing and seal wear was reduced. These coupling have now run for **over 8 years** with zero maintenance or adjustment saving Fellside considerable time and money.
